## Wear characteristics of gas turbine fuel nozzle-contacting surface at different contact temperatures

To cite this article: Pauzi et al (2019). Wear characteristics of gas turbine fuel nozzle-contacting surface at different contact temperatures. *Jurnal Tribologi* 21, pp.108-122.

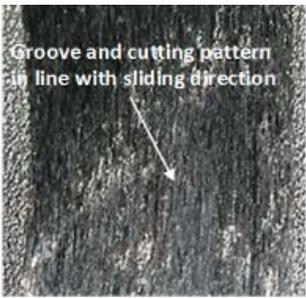
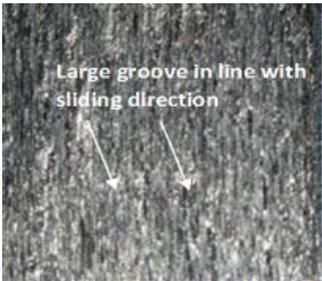
Evidence of adhered materials</p> <p>4 mm</p>	<p>(b)

Evidence of delaminated region</p> <p>6 mm</p>
100 °C	<p>(c)

Adhesive terrace Delaminated region</p> <p>4 mm</p>	<p>(d)

Groove and cutting pattern in line with sliding direction</p> <p>6 mm</p>
200 °C	<p>(e)

Adhered materials Groove pattern</p> <p>4 mm</p>	<p>(f)

Large groove in line with sliding direction</p> <p>6 mm</p>

Figure 2: Visual observation of pin-on-disc wear test for SS 304-Hastelloy X. tribo-pair at (a) 25 °C pin, (b) 25 °C disc, (c) 100 °C pin, (d) 100 °C disc, (e) 200 °C pin and (f) 200 °C disc.

Figure 2 shows the results of the wear test that was conducted. Three different temperatures were used during this study, namely 25 °C, 100 °C, and 200 °C. The tribo-pair materials were tested under these three different contact temperatures to investigate the effect of the contact temperature on the wear mechanism. The contact temperature is one of the main factors to be considered during the operation of industrial gas turbines.

For the tribo-pair between SS 304 and Hastelloy X in Figures 3 (a), (c) and (e), the wear on the pin surface showed a similar jagged pattern at three different temperatures. This proved that the jagged pattern tended to be formed at the tribo-pair surfaces and had a significant effect on the increase in wear of the combustor components materials. The wear on disc surface further showed a similar pattern of cuts and grooves at the three different temperatures. Theoretically, surfaces that are subjected to a higher load will exhibit severe wear (Chen et al., 2015 and Umashankar and Annamalai, 2017).

For gas turbines under real conditions, the jagged and cut pattern tends to be formed at the contacting surfaces of the fuel nozzle and combustion liner, and the severity of the wear will increase with an increase in time. From the visual observation, it was found that adhesive and abrasive behaviour existed on the tribo-pair between SS 304 and Hastelloy X.
