The wear of the taper junction of the stem trunnion with the femoral head of a total modular hip prosthesis

Lucian Capitanu ¹, Liliana-Laura Badita ^{2*}, Constantin Tiganesteanu ¹, Virgil Florescu ³

To cite this article: Capitanu et al. (2019). The wear of the taper junction of the stem trunnion with the femoral head of a total modular hip prosthesis. Jurnal Tribologi 23, pp.61-75.

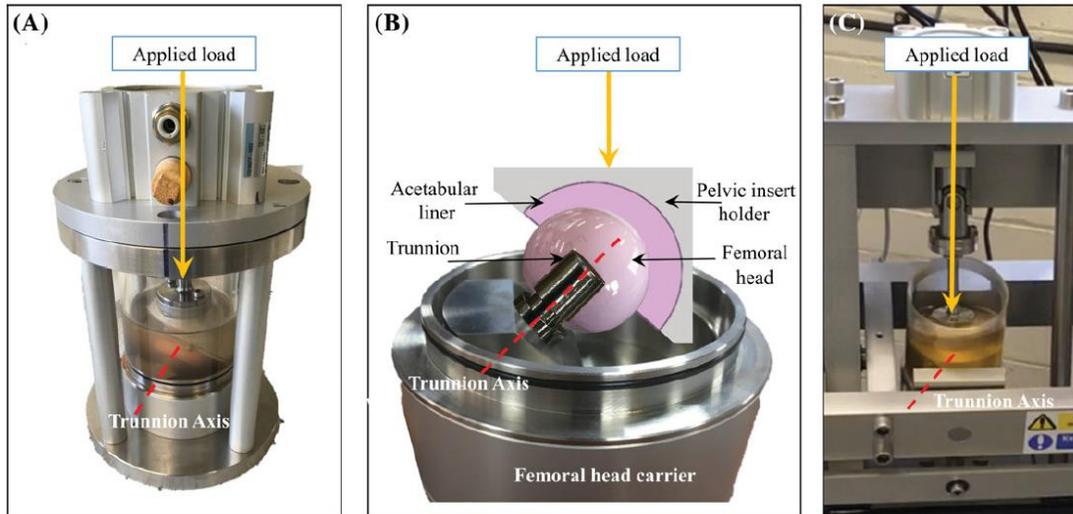
Figure 1: (A) A DL station. (B) Scheme of the femoral head, acetabular and trunnion liner in the test and in the DL station. (C) A test station (Bhalekar et al., 2018).

The lubricant was changed every 500,000 cycles when the components were cleaned and weighed in accordance with the relevant international standard, ISO 14242-2.26. In addition, a neutral detergent was used to eliminate any visual trace seen after disassembly on the inner taper of the femoral heads and the back of the liners. To study the wear of the stem trunnion taper junction with femoral head, a CoC joint sample was tested on a DL station with a minimum charge of 400 N and a maximum charge of 2000 N, but without the articulation movement, hereinafter referred to as the "DL test station", Figure 1(A, B).

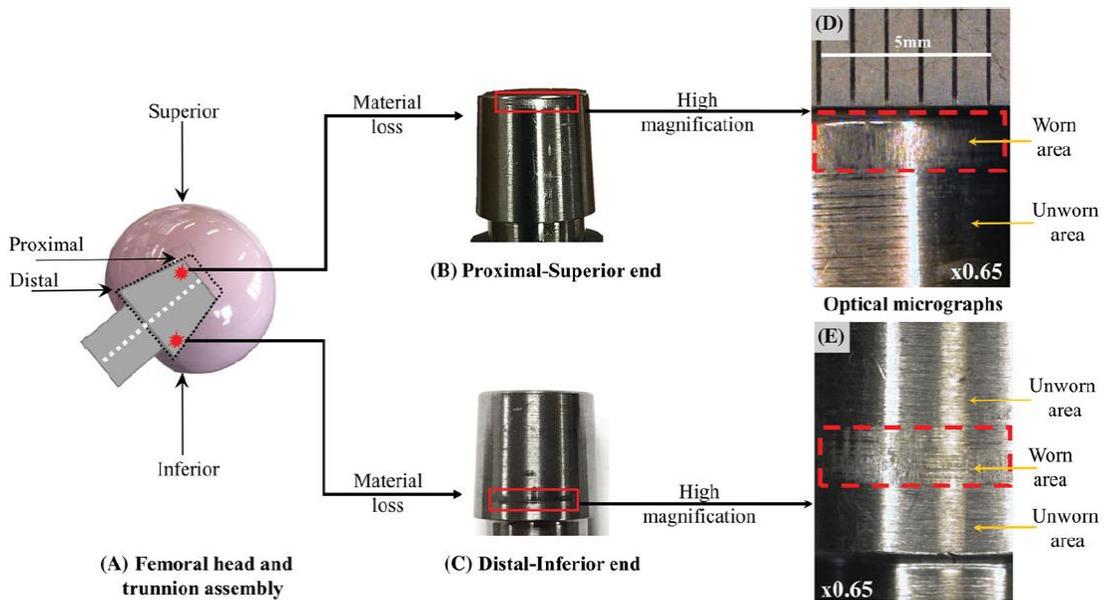
Figure 2: (A) A femoral head and femoral assembly showing the different anatomical planes (B, C) a test trunnion indicating wear at the proximal – superior end and at the distal – inferior end, respectively (D, E) optical microscopic images captured at a 0.65x magnification showing worn and unworn areas of the superior – proximal end and the distal – inferior ends (Bhalekar et al., 2018), respectively.

In turn, each trunnion was placed in a femoral head holder – see Figure 2(A-C). The 12/14 taper trunnions with a 34.5 mm neck length were manufactured by Phoenix Tribology Limited, UK, based on the Corail stem (DePuy Synthes, UK) which, when used with 36 mm ceramic heads, give the CoC hip joint most commonly implanted in the UK.

The head and trunnion assembly are shown in Figure 2(A). On the trunnions, the loss of material (as indicated by the reduction of the mass and the decrease of the roughness) was seen opposite the superior – proximal end and the distal – inferior end, respectively, as shown in Figure 2(B, C).

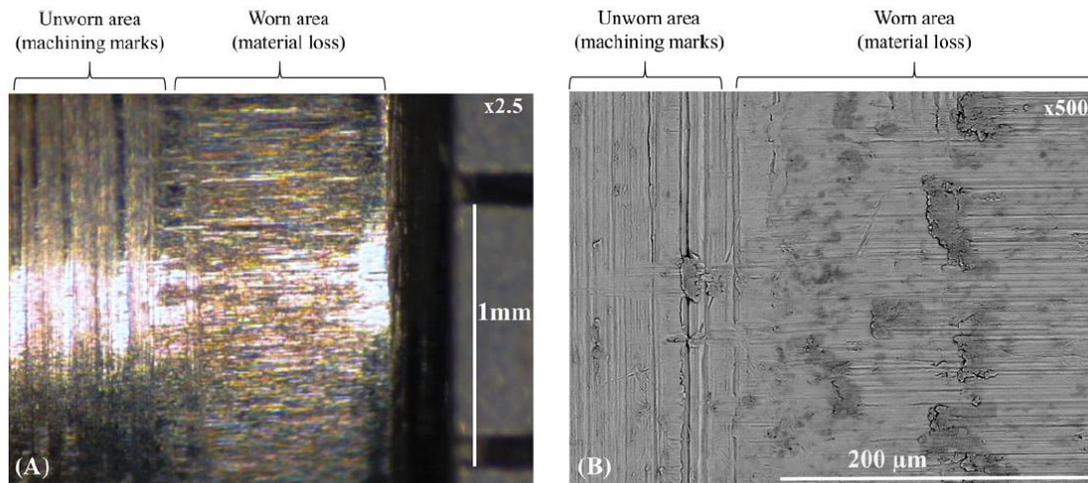
Figure 3: (A) An optical microscopic image at $2.5\times$ magnification and (B) the microscopic scanning electronics (SEM) image at $500\times$ magnification of test trunnion, showing worn and unworn areas (Bhalekar et al., 2018).

Unworn and worn out areas are clearly visible, and the original circular machining marks are evident in unworn areas. The proximal – superior end of a test trunnion can be seen in Figure 3(A) at a magnification of $2.5\times$, using an optical microscope and at a magnification of $500\times$ with a SEM in Figure 3(B). In figure 3(B), considering the use of a more advanced microscopic system and a larger magnification, it is observed that even in the unworn area, small traces of wear appear. There are several small areas, where the loss of material is observed, as pronounced as in the worn areas.

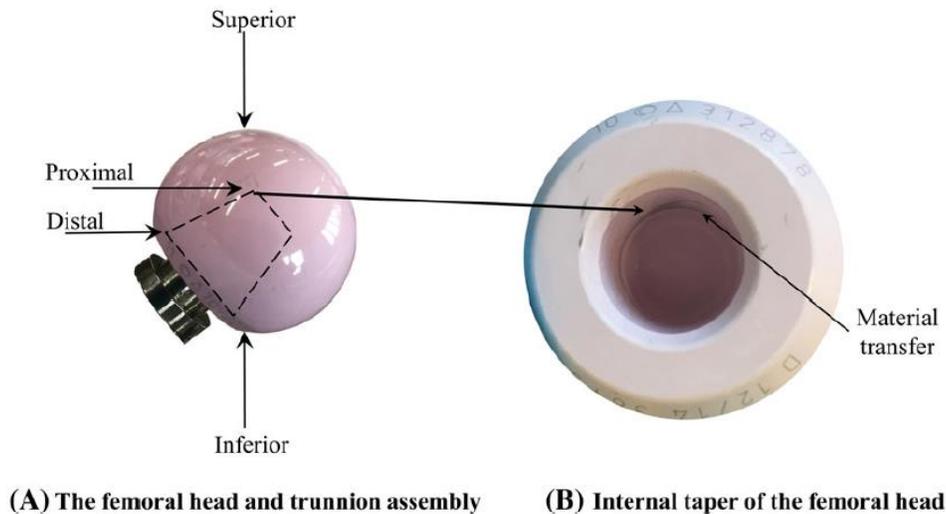
Figure 4: (A) A femoral head and a trunnion – head assembly, showing the various anatomical planes. (B) Internal taper of a tested femoral head showing a grey ring (Bhalekar et al., 2018).

Figure 4 shows femoral head and a trunnion – head assembly, showing the various anatomical planes and internal taper of a tested femoral head showing a grey ring (Bhalekar et al., 2018).

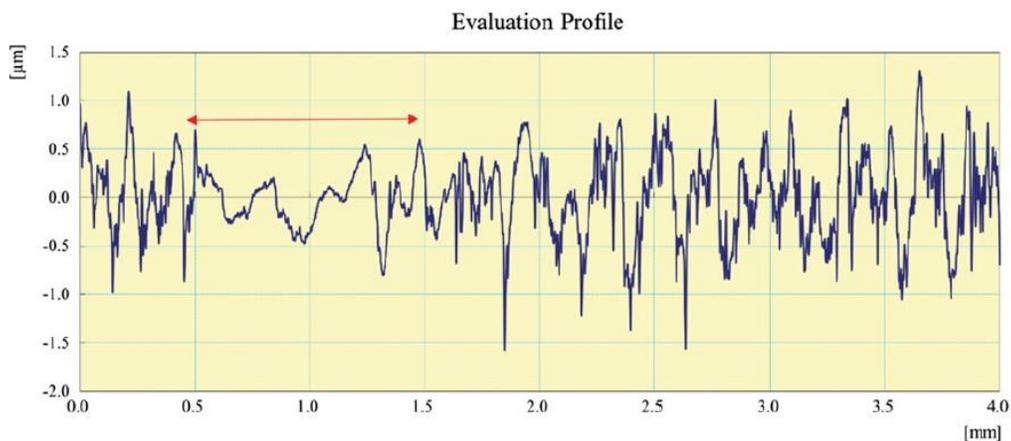
Figure 5: An evaluation profile obtained at the distal – inferior end of a test trunnion ($R_a = 0.321$ μm). The red arrow marks the worn area.

Figure 5 shows an evaluation profile of a trace obtained on the distal – inferior end of a test area, which shows the worn area.

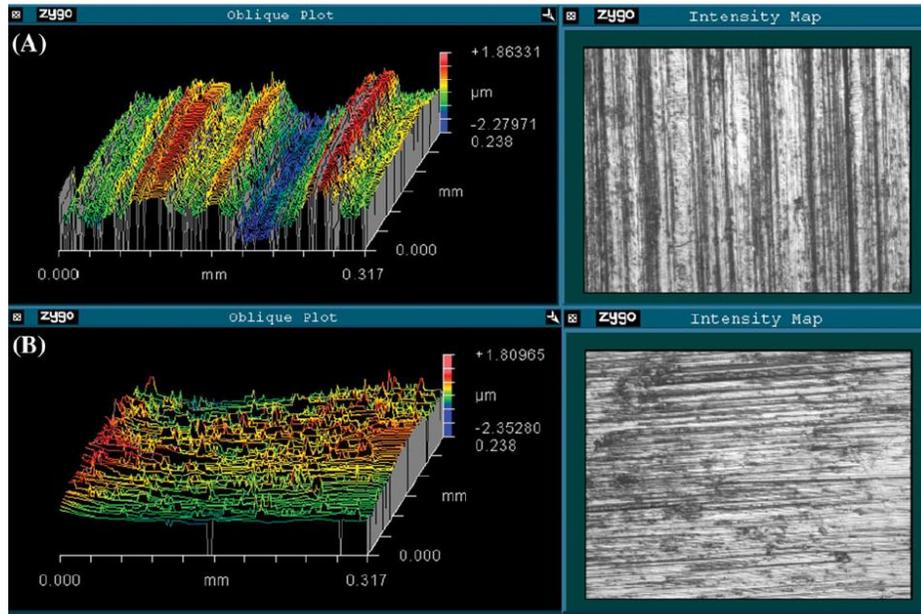
Figure 6: Images of surface topography of a titanium trunnion (A) surface with no visible machining marks ($R_a = 0.565 \mu\text{m}$) and (B) worn ($R_a = 0.284 \mu\text{m}$) (Bhalekar et al., 2018).

Figure 6(A, B) shows profile images acquired with the non-contact profilometer on (A) unworn and (B) worn areas from the superior – proximal end of a tested trunnion.

In the unworn area, the original marks of processing can be observed, but no such marks have been observed on the unworn area. The R_a roughness of the trunnions in the unworn and worn areas showed a statistically significant decrease from 0.558 ± 0.060 to $0.312 \pm 0.028 \mu\text{m}$ ($p < 0.001$), respectively.

Based on the wear data of the hip simulator, the metal trunnions (total wear = 0.29 mm³) were worn with a quantity similar to that of the bearing surfaces (total wear = 0.25 mm³). Trunnion surfaces measured with a 2D contact profile showed a statistically significant decrease in surface roughness (R_a) after testing (see Figure 5). In addition, the worn area showed a statistically significant decrease of the 3D surface roughness (R_a) compared to the area of the unworn area (see Figure 6).

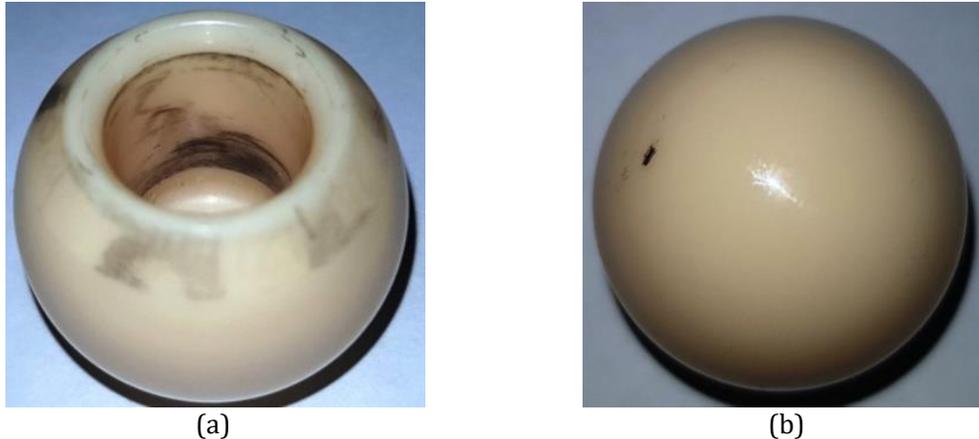
Figure 7: (a) An internal taper of the femoral head tested at impact on the stem, showing grey marks of micro-movement and fretting wear, prior to cleaning, and (b) a metallic wear particle embedded in the outer surface of the ceramic head.

The dark grey traces of the inner taper of the femoral head during this test, as well as the transfer of the material, are shown more clearly in Figure 7. They illustrate micro-movement and wear through fretting, and a metal wear particle embedded in the outer surface of the ceramic femoral head.

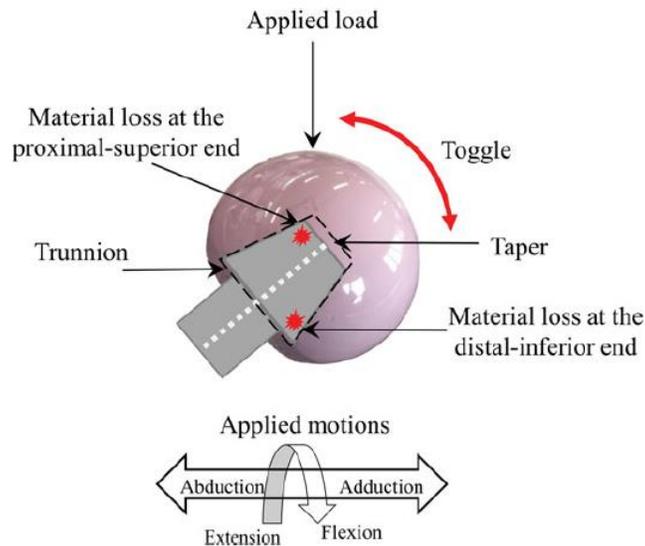
Figure 8: A ceramic and beaded femoral head test set with applied load and applied movements indicating the overturn and loss of the material in two distinct areas (shown in red).

Overturning of the cobalt chromium head (CoCr) on the stem of MoM modular hip was also the cause of the wear at the taper – trunnion junction. Because a similar wear pattern was observed in this simulation study, it suggests that "there is a similar change in the position of the ceramic femoral head" as shown in Figure 8.

The femoral head position changes due to the loss of material on the taper junction of the head and trunnion. The wear of the trunnion is probably due to the relative hardness of ceramics compared to titanium or may be the result of shocks due to micro-separation. After this process, wear stripes formed on the surfaces of the femoral head, a result similar with another obtained by Langton et al., (2017).
