Effect of cutting speeds on wear performance of 22MnB5 boron steel when machining with Al 6061 aluminum alloy

To cite this article: Abu Bakar et al (2022). Effect of cutting speeds on wear performance of 22MnB5 Boron Steel when machining with Al 6061 Aluminum alloy. Jurnal Tribologi 34, pp.12-23.

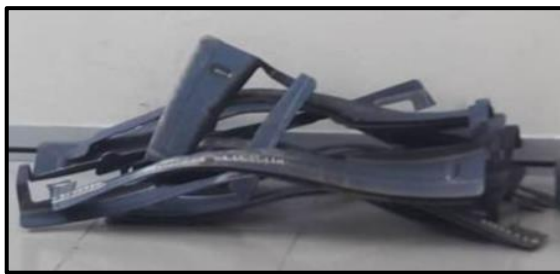
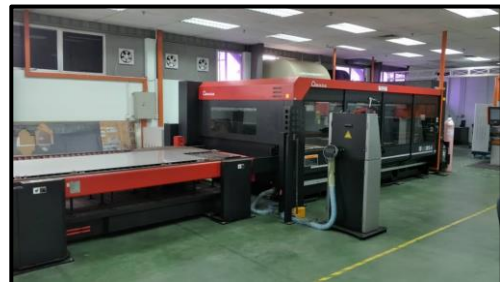
Figure 1: (a) Quenched 22MnB5 boron steel (b) Laser cutting machine

Figure 1 depicts the original state of quenched 22Mnb5 obtained through the hot stamping process. The chemical properties of 22Mnb5 are shown in Tables 1. To convert 22Mnb5 metal sheet into cutting tool, a laser cutting machine (Figure 2) was used to cut 22m\Mnb5 sheet into RNGN 120300 tool insert. CRDN252543 tool holder was used to clamp the insert for the machining trials.

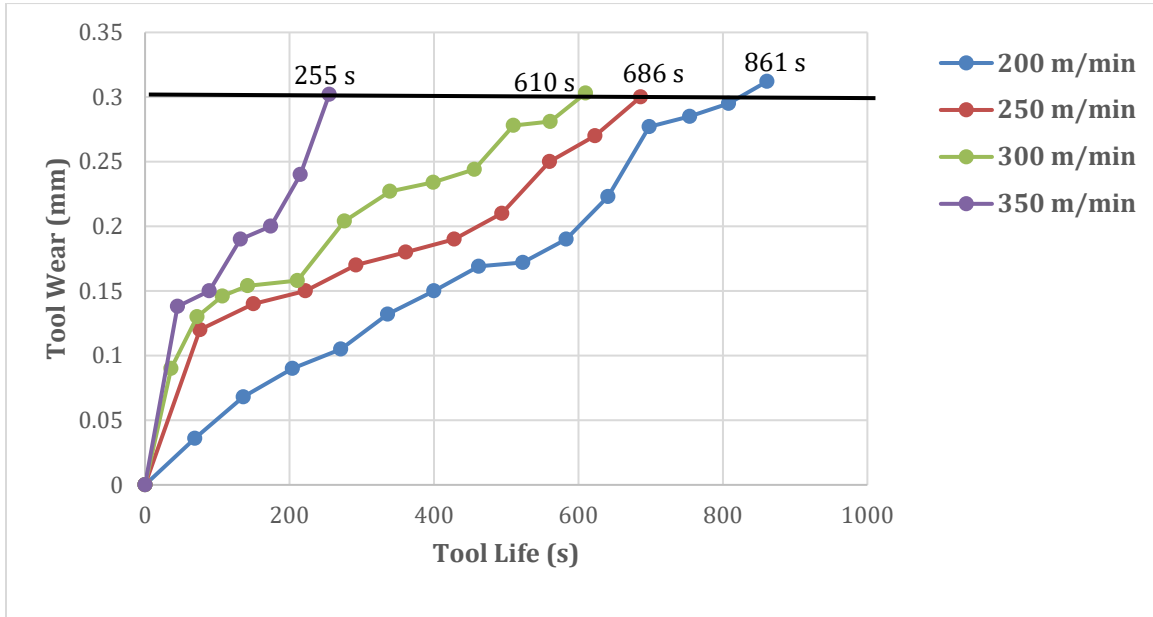
Figure 4: Effects cutting speeds on flank wear for 22MnB5 boron steel cutting tool at the 0.1 mm/rev feed rate and 0.5 mm depth of cut

Figure 4 depicts the effects of cutting speeds on flank wear for a 22MnB5 boron steel cutting tool at a feed rate of 0.10 mm/rev. Machining at a cutting speed of 200 m/min shows a linear trend in tool wear development, indicating a smooth machining process until it reached tool life at 861 s. When machining was held at 250 m/min, wear slightly increased in the early stages of machining before becoming more stable as the machining prolonged, reaching 686 s tool life. Similar to the cutting speed of 300 m/min, tool wear spiked during the initial machining and gradually stabilized to record tool life at 610 s. Machining at the highest cutting speed of 350 m/min demonstrated high tool wear within a short time of machining trials and was gradually increased to perform a short machining period of 255 s.

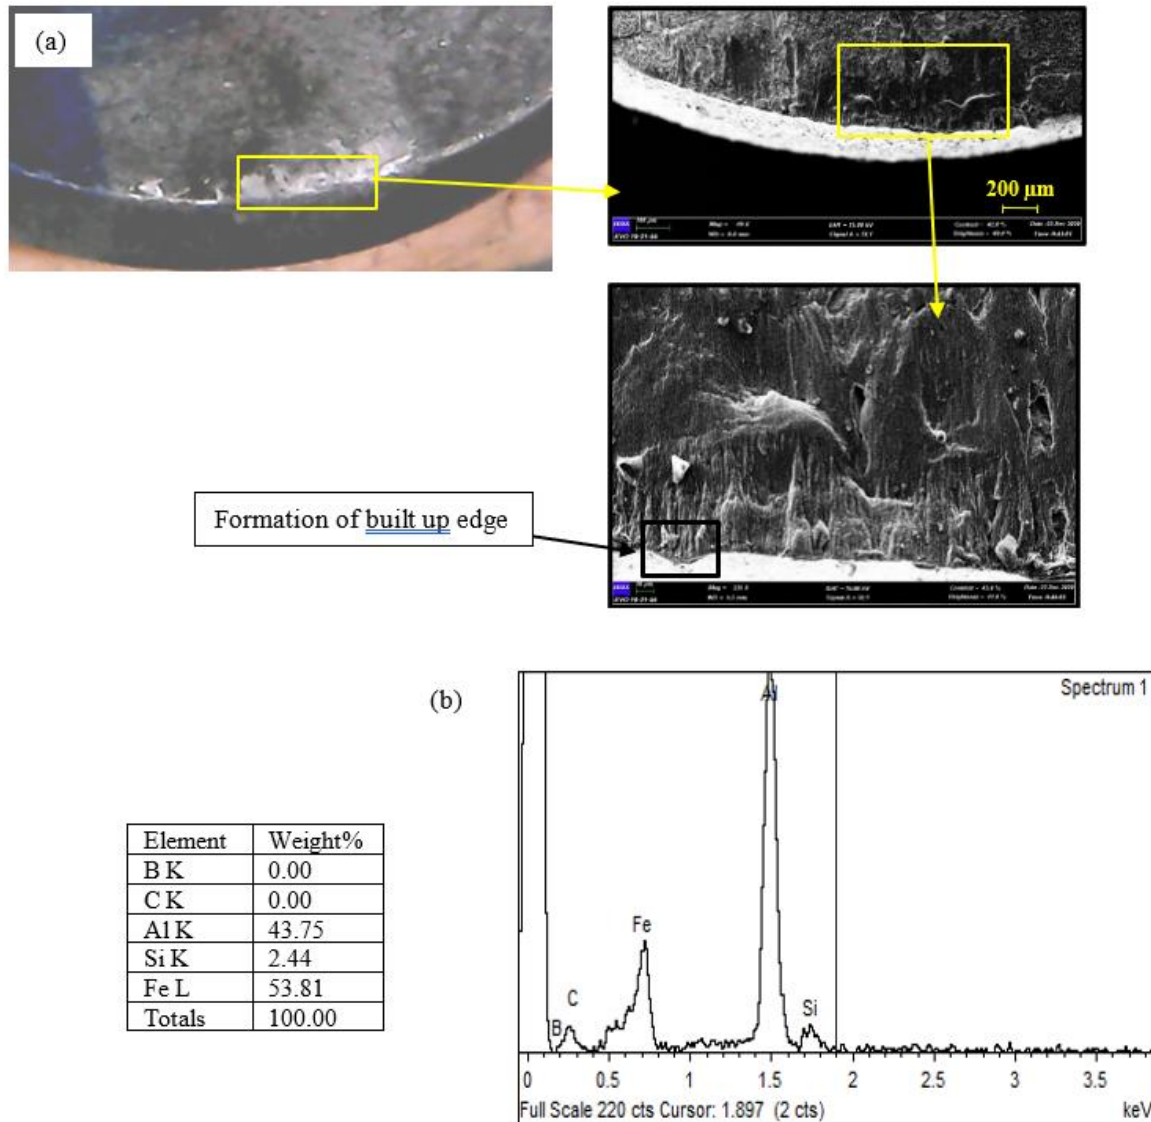
Figure 8: (a) Crater wear observation at the cutting speed of 350 m/min. (b) EDX analysis on the selected area of deposited layer

Figure 7(a) and Figure 8(a) show the observation of crater area on the cutting edge of 22MnB5 when machined at 200 m/min and 350 m/min respectively. The formation of an adhesive molten aluminum layer in the form of a lamellar layer was observed in the crater area for both samples. This is true for both samples observed with EDX analysis shows that Al with 72.33 wt% (Figure 7(b)) and 43.75 wt% (Figure 8(b)) were detected on the attached layers. Large content of Al indicates that such Al elements originated from Al 6061 workpiece since the Al content in the 22MnB5 cutting tool is only 0.03 wt%. Material transfer from workpiece to tool rake face indicated that built-up edge (BUE) was formed on the crater surfaces (Ozbek et al., 2016 and Ozbek, 2020).

At a low feed rate of 0.1 mm/rev, the adherent chip is specifically covering the contact region on the crater face. Material lost within the crater wear area was contributed by layer-by-layer removal from rubbing action. At this temperature, crater formation occurred as a result of the chip alternately slipping and sticking on the rake face. Furthermore, the combination of localized temperature and dynamic friction accelerated material loss at the sliding region. Once a crater is formed, the high localized compressive stress combined with the faster traverse movement of the cutting tool plays an important role in bending the continuous chip, resulting in the formation of a discontinuous chip (Jianxin, et al., 2011 and Sarjana et al., 2020). Such molten metal existence also may result within the most noticeable sign of adhesive wear.
