## Experimental investigation on tool wear and surface integrity during wet and dry milling of carbon fiber reinforced polymer (CFRP)

Maisarah Abdul Mahad, Nor Farah Huda Abd Halim \*, Aisyah Madihah Mustafa

Department of Manufacturing and Materials Engineering, Kulliyah of Engineering, International Islamic University Malaysia, MALAYSIA.

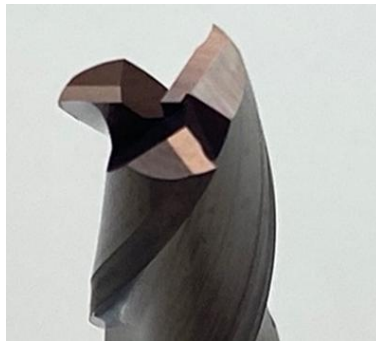
Figure 3: 8 mm diameter of uncoated tungsten carbide tool with 3 flutes.

Table 2: K3EPEN 080U tungsten carbide end mill tool specification.

Parameter	Specification
Tool diameter, D	8 mm
Shank	8 mm
Overall length (OL)	50 mm
Length of cutting (LOC)	14 mm
Number of flutes	3

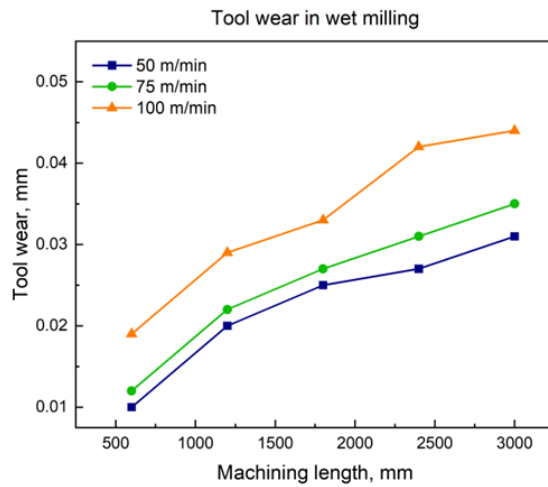
Figure 8: Tool wear progression in milling CFRP with 475 mm/min feed rate and 1 mm depth of cut in wet cutting conditions.

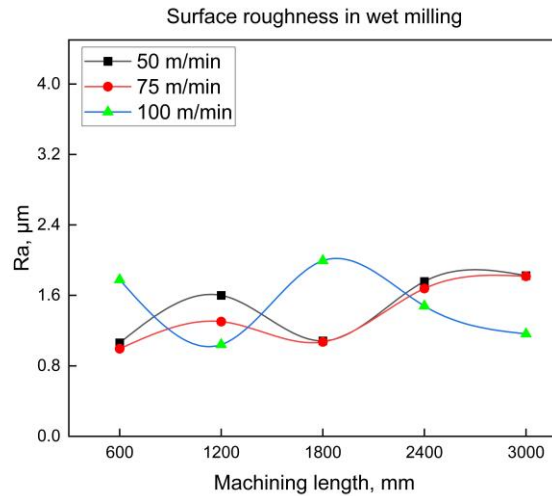
Figure 11: Surface roughness value, Ra, in wet milling over 3000 mm length.

The surface roughness progresses in milling at the cutting speeds of 50, 75, 100 m/min in dry and wet cutting conditions is compared in Figure 10 and Figure 11, respectively. It can be observed that the roughness varies as the machining length increases for all cutting speeds in both cutting conditions. The occurrence of tool wear along the machining length and the development of rounding on the cutting tool edge during the milling of CFRP create damage to the machined surface and result in poor surface roughness [15].

In milling with wet cutting conditions, an unexpected observation between the surface roughness and the cutting speed was recorded after milling through the machining distance of 3000 mm, as the surface roughness, Ra, decreased with the increase in cutting speed. At 3000 mm of machining length, the highest cutting speed of 100 m/min shows a better surface roughness of 1.163 µm, while the highest surface roughness, Ra of 1.825 µm was produced by the lowest cutting speed of 50 m/min, 36.3% higher compared to milling at 100 m/min. The surface roughness profiles in Figure 14 and Figure 15 shows significant differences in the Ra values produced during wet milling. Figure 15, at a cutting speed of 50 m/min shows more variations in peaks and valleys, resulting in a higher Ra value (Ra=1.825 µm).

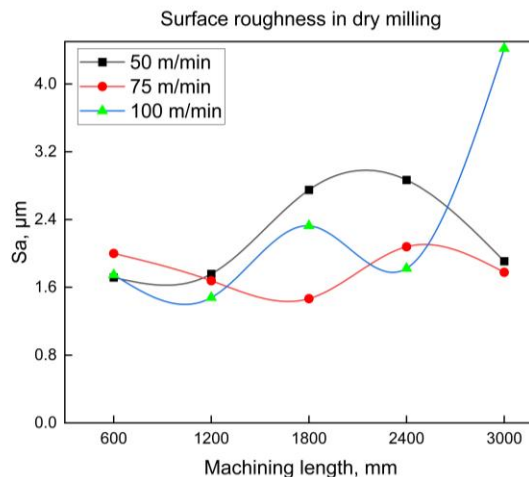
Figure 16: Areal surface roughness value,  $S_a$ , in dry milling over 3000 mm length.

According to Figure 16, it can be observed that the highest areal surface roughness value,  $S_a$ , as machining over 3000 mm of machining length in dry cutting conditions was 4.419  $\mu\text{m}$ , which is at the highest cutting speed of 100 m/min. While the cutting speeds of 50 m/min and 75 m/min showed lower  $S_a$  values of 1.909  $\mu\text{m}$  and 1.778  $\mu\text{m}$ , respectively. In regards with the rate of tool wear in Figure 7, it can be seen that the tool wear is higher at the highest cutting speed. This justifies the higher  $S_a$  values, as the worn out tool contributes to an increase in cutting force during machining process, leading to damage on the machined surface (Xu, 2022). The areal surface roughness values,  $S_a$ , can be confirmed with the surface topography shown in Figure 17(a) and Figure 17(b). According to the height subrange of the surface topography shown in Figure 17(b), some parts on the scanned surface exceed the acceptable height subrange, indicating poor surface roughness and damage in machining at a cutting speed of 100 m/min. The blue and purple colours in the pseudo-colouring of the height subrange indicate damage such as fiber pull-out and delamination. This occurs as the fibers break and separated as machined with a worn-out cutting tool, leading to fiber pull-out and an increase in delamination depth (Ozkan et al., 2020). In

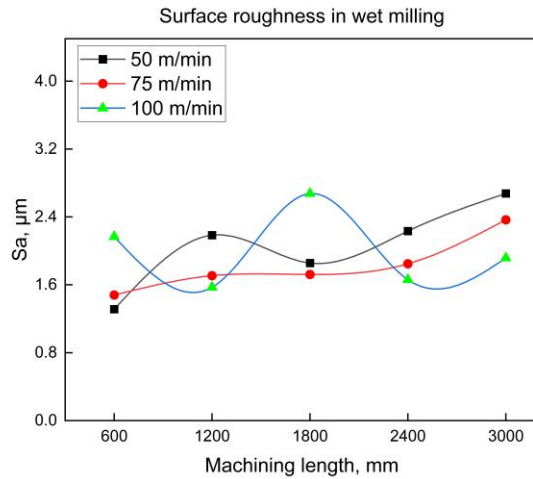
Figure 18: Areal surface roughness value, Sa, in wet milling over 3000 mm length.

Different observations on the effect of cutting speed on the Sa values were found as machined in wet cutting conditions as seen in Figure 18. The lowest cutting speed of 50 m/min gives the highest Sa value of 2.676  $\mu\text{m}$ , 28.4% higher than the Sa value produces by the highest cutting speed of 100 m/min (1.916  $\mu\text{m}$ ). It can be seen that the highest cutting speed of 100 m/min produces the lowest Sa value, which can be caused by the high temperature generated during the process, that created smearing of the material which smoothen the surface of CFRP (Kumar et al., 2020). This can be confirmed by the green indication in the pseudo-colouring of the height subrange displayed on the surface topography in Figure 19(a). The high Sa value produced by the cutting speed of 50 m/min is to be due to the poor condition of the cutting tool, which has begun to wear out at the machining distance of 3000 mm as illustrated in Figure 9. Figure 19(b) shows the damages on the surface that are displayed by the blue indication in the pseudo-colouring of the height subrange. This shows the occurrence of damage, such as fiber pull-out and delamination caused by the cutting tool, that leads to the high Ra and Sa values.
